# **Assessment of the Technical Condition of the Reinforced Dome Construction of the Kalyan Mosque under the Influence of Seismic Forces**

**Z.S. Shadmanova, B.K. Raxmanov, A.S. Yuvmitov**

**ABSTRACT:** In the article was analyzed the technical condition of the dome construction of the Kalyan Mosque in Bukhara after reinforcing with metal profiles as a result of theoretical calculations. Using a special computer program, the dome structure was calculated separately from the accelerogram of the existing SA-482 model by the finite element method, and its stress-strain state was determined.

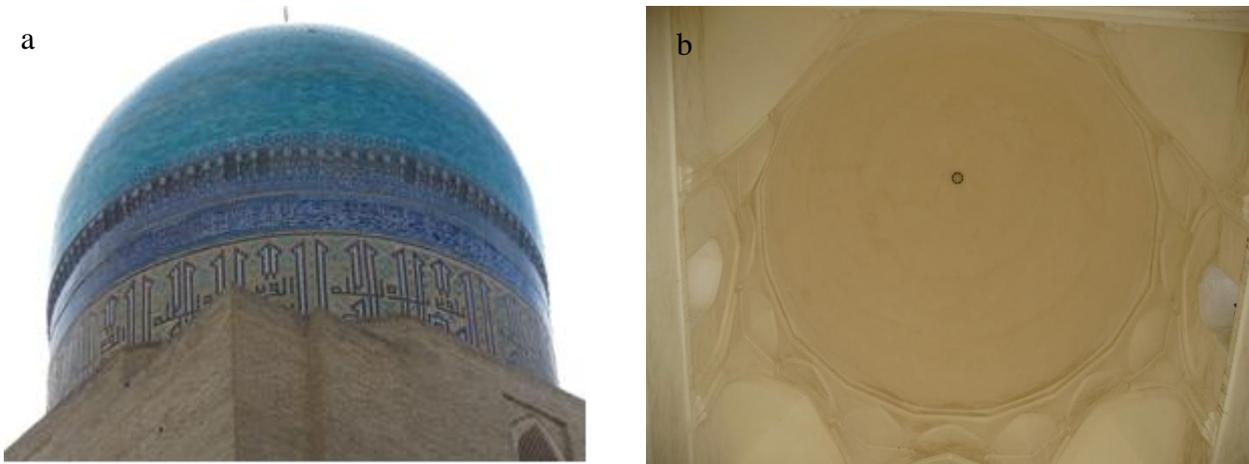
Due to the earthquake, the domed porches connecting the four components of the mosque complex were completely destroyed. Today, some of their column foundations have been preserved. In 1967, the Institute of Reconstruction developed a project to repair the Kalyan Mosque in Bukhara, but for some reason the mosque complex remained unrepaired. However, restoration and restoration work has been carried out in different years. An example of this is the restored condition of the roof and dome of the Kalyan Mosque (Figure 2) .

**Figure 2.** The dome of the main mosque building (a) and view from the inside (b)

The mosque has been undergoing restoration and repair work for several years. The last repair was made in 2002. According to him, the south courtyard roof, north side pillars and the main dome have been renovated. The north pillars have been rebuilt from concrete. Reinforced concrete and metal structures were used in the reconstruction of the roof and main dome [4].

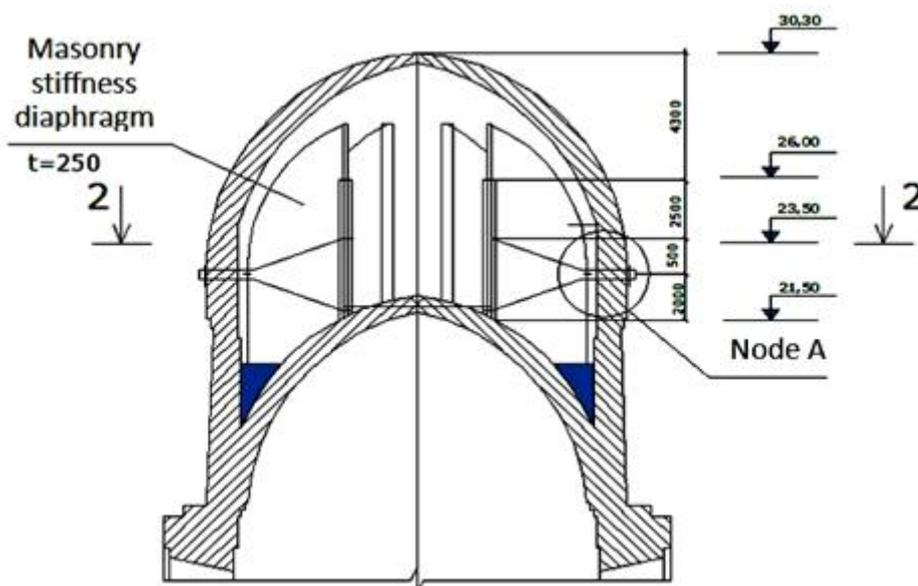
The main material of the entire mosque complex is burnt brick, the dimensions of which are 0.22x0.22x0.05 m. These bricks were assembled using a mixture of gypsum [5]. One of the main structures of the mosque is the dome structure, which was damaged during the earthquake and was quite damaged. During the repair, it was reinforced with a cable-stayed construction using steel profiles, which was not entirely based on engineering calculations. The brick buttress diaphragms located on the inner side of the dome under the dome are attached to the connecting belt using rolled channels and are attached to the drum wall using bolts and nuts using a steel rope. Due to the fact that most of the republic's territory is located in seismic zones, a theoretical study of the influence of this strengthening structure on the structure of the drum during an earthquake is important and relevant. One of the main solutions to this is to perform computational work using Lira Soft based on the finite element method available in construction practice [6]. The geometric dimensions of the drum structure and the strengthening steel profiles in it are shown below (Figures 3, 4, 5).

**Figure 3.** The section of the dome construction of the main mosque (1-1)

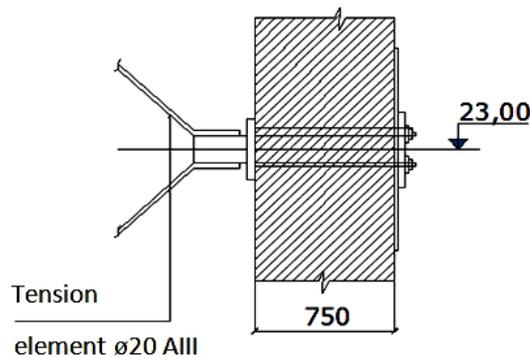
Figure 5. View of the wall of the drum construction with tensioning elements (Node A)

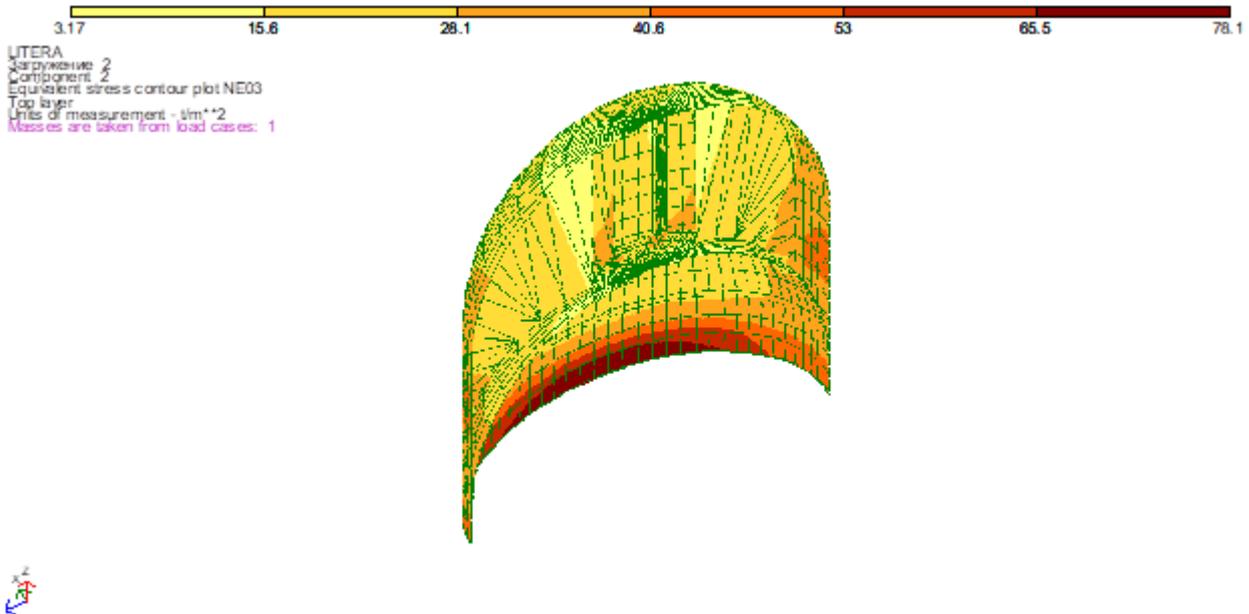
Figure 9. Isofield of tensile equivalent stress at the walls before strengthening of the dome

The maximum value of the equivalent tensile stress in the walls of the dome structure varied before reinforcement is 65.5 H/cm<sup>2</sup> in the range of 78.1 H/cm<sup>2</sup>, but increased from 5.46 H/cm<sup>2</sup> to 94.7 H/cm<sup>2</sup> after its strengthening. This value is due to the stress of the reinforcing elements under the influence of dynamic forces.

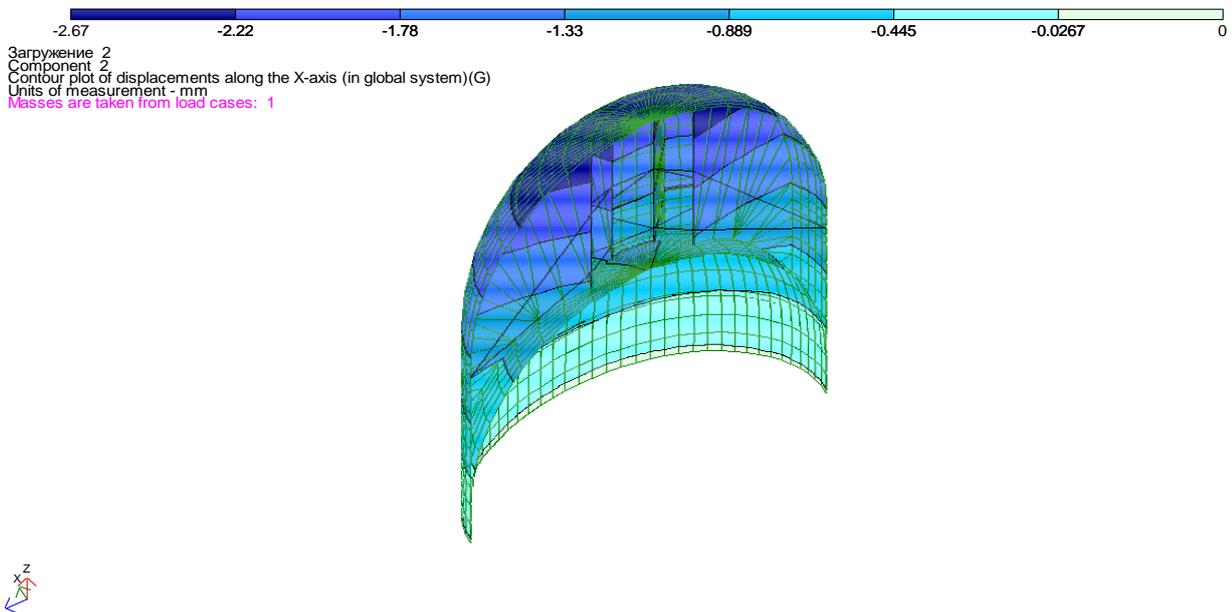
Figure 10. Isofield of displacement on the horizontal direction after strengthening of the dome

The obtained numerical results show that the horizontal displacement decreased from 2.81 mm to 2.67 mm after strengthening the dome structure.

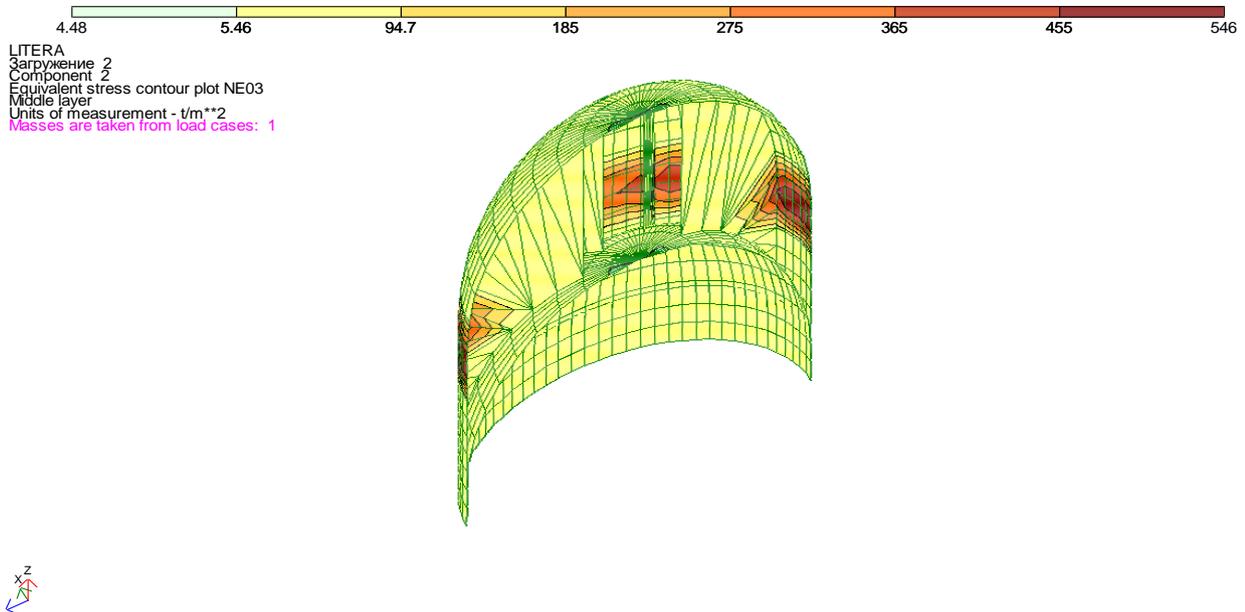
Figure 11. Isosurface of tensile equivalent stress at the walls after strengthening of the dome

1. The average equivalent value of the tensile stress in the walls after strengthening the design of the dome using steel profiles reduced by 11 times, but as a result of the load of strengthening bar elements on the areas where the traction area is located increased by 1.2 times;

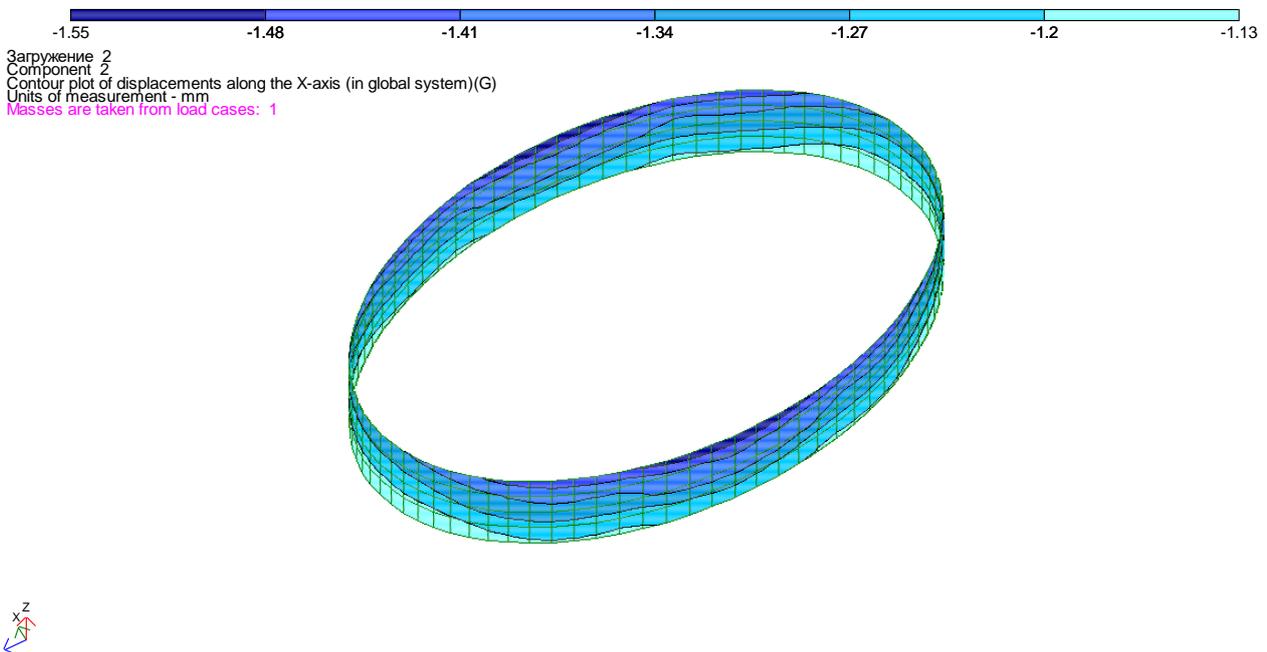
Figure 12. Isosurface of horizontal displacement of plate-like traction element

The horizontal displacement of the plate tension element was 1.55 mm, and the maximum equivalent tensile stress value was 958 H/cm<sup>2</sup>.

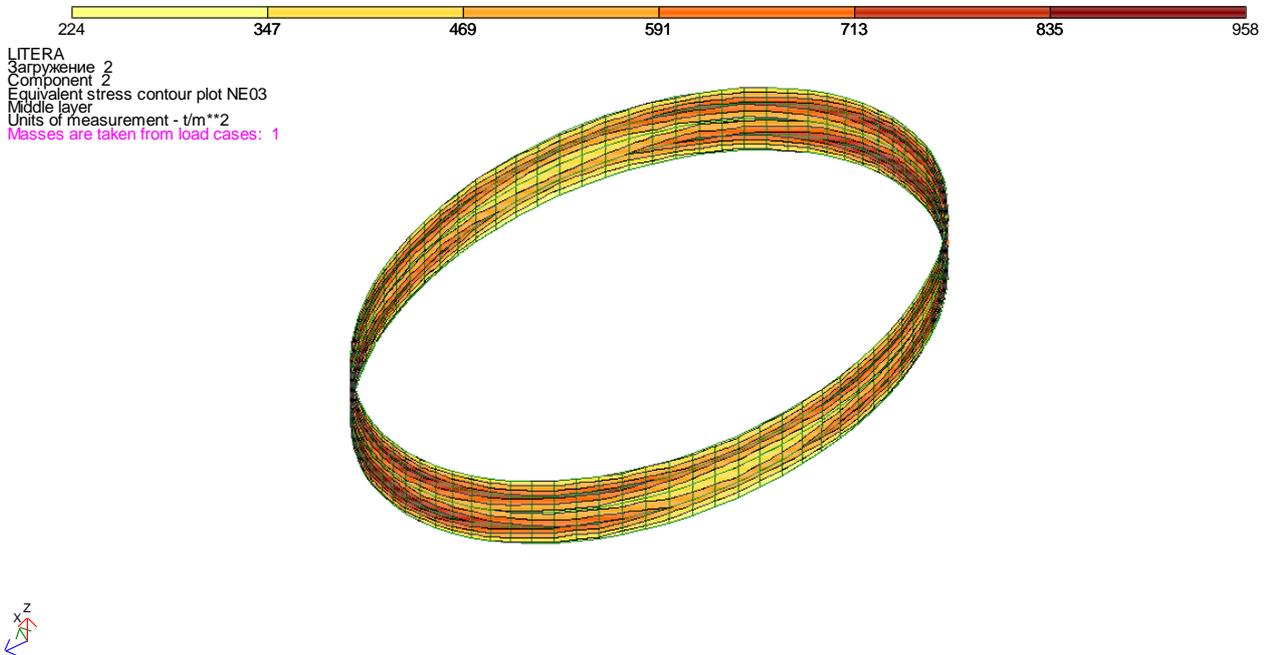
Figure 13. Isofield of tensile equivalent stress of plate-like traction element

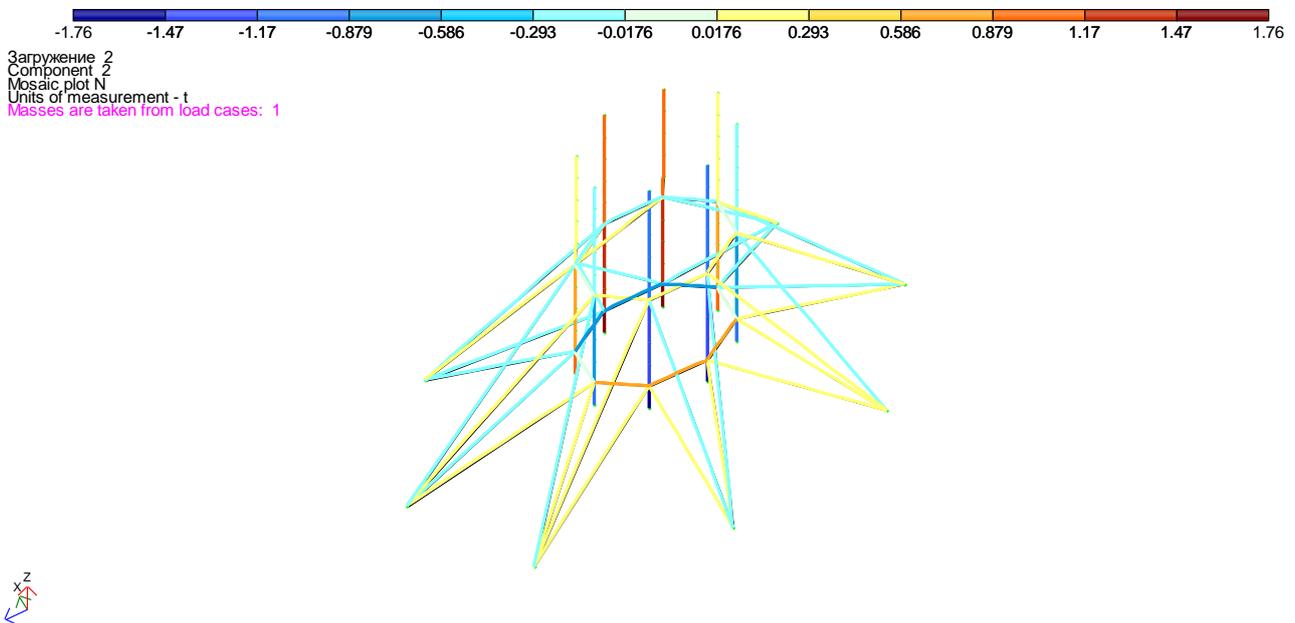
Figure 14. Longitudinal force mosaic of the steel bar elements, reinforced the dome construction

The maximum value of the longitudinal forces in the elements of the reinforcing bar was 17600 H, which did not exceed the allowable stress value. As a result of the calculations and analysis of archival materials, the following conclusions can be drawn:
