**International Journal of Advanced Research in Science,
Engineering and Technology**

Vol. 6, Issue 1, January 2019

Study of Heat Loss through Air Gaps in Bhutanese Window Fittings and Walls-A Case Study

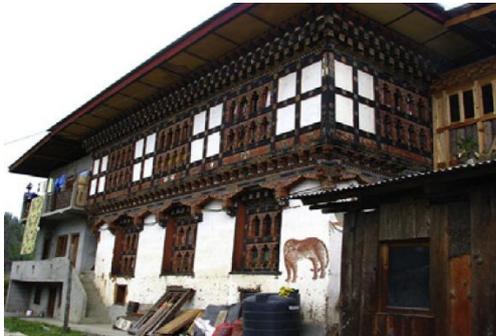
Figure 3: Building 01: Traditional Farm House

This two storey village farm house located at an altitude of 2478 m, was constructed in 1995 using locally available rammed earth using the traditional construction techniques with the upper floor partially in timber-framed structure known as rabsel. However, later on extensions was made with reinforced concrete frame structure. Initially, the ground floor was used to keep cattle and the first floor served for residential purposes. Currently, both the floors are used as residential purpose.

Out of four the buildings, it was analyzed and found that the worst performing building was the two-storied traditional farmhouse with air infiltration rate of 5.3 h⁻¹, despite the building constructed with locally available rammed earth using vernacular construction technologies. Rammed earth is considered as an energy efficient building material (Minke, 2000; (Morgan, 2008; Venkatarama, 2014) due to its thick thermal mass, which act as a huge heat sink and absorbs solar energy during the daytime keeping the indoor environment cool and keeps the structure warm at night. However, due to poor construction technology and the presence of putlogs, considerable heat was lost in this farm house. On the contrary, the modern rammed earth construction adopted by the library building in RUB has a minimum heat loss through its walls, which was denoted by the substantial temperature variation. The heat loss through windows were observed in both cases, which has occurred through the joints between elements of the wooden casements, window frames and window lintels as interpreted from the thermograms.

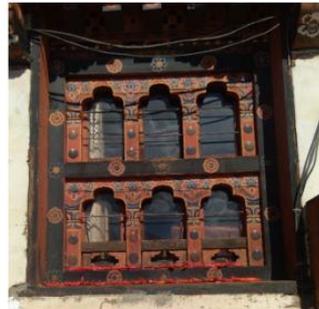
Figure 3: Front elevation of the window

Thermal imaging of the singly glazed HorgoPagab window in the ground floor as shown in Figure 3 was done to understand and comprehend the heat loss through the timber window made with no sealing. It was carried out on 27th October, 2018 at 1:45 P.M. with the outdoor and indoor temperature of 17°C and 10°C respectively. The level of humidity was 36% and the wind velocity of 6 km/h. It was found that the inner surface temperature of the window frame was 10.9 °C shown in Figure 4 and outside was detected as 16.2 °C as shown in Figure 5 with a temperature difference of 5.3 °C.

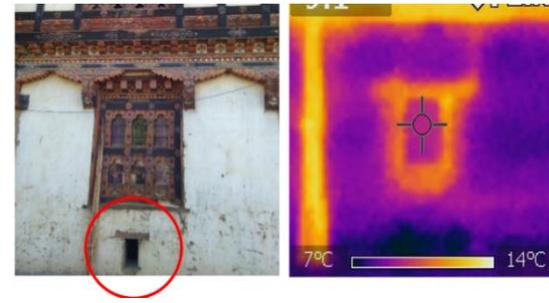
Figure 7: Thermogram of Gedkar payab

According to the Energy saving regulations EN 13829: 2000, the n50 value of a new building must not exceed 3 h⁻¹ (ENEV, 2001). However, the air infiltration of this building was found to be 5.3 h⁻¹ as per study carried out by (Jentsch et al, 2017) on the same building. This establishes that the building is leaky as Thermogram images of Figure 5 and 6 show that maximum amount of heat is lost through air leaks from the various joinery of a window frame. It was found that the joineries are found to be poorly finished and does not have proper sealant in the window frames while doing visual physical verification as shown in Figure 4. Similarly, huge amount of air infiltration occurs through walls due to putlog holes as shown in Figure 6 and cracks developed around these holes in due course of time which further add to the air infiltration rate. Similarly, Gedkar windows which were traditionally used as ventilators, significantly add to the air infiltration as shown in figure 7.

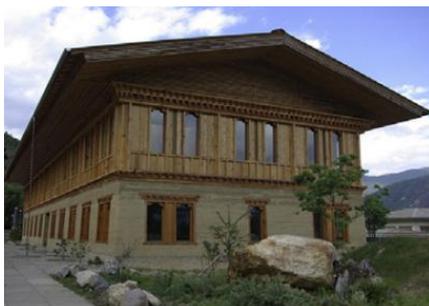
Figure 8: Building 02-University Library building, OVC

The two storied Library building of the Office of the Royal University building was constructed in 2014 with locally available rammed earth without putlog holes on the ground floor and the upper floor with a timber-framed structure (rabsel) using modern technologies. It is located at an altitude of 2445 m in Motithang, Thimphu.

However, it was observed that the double glazed window in the library building had very low thermal transmittance with minimal heat loss compared to singly glazed window in the traditional building. It was found that the heat lost from the air gaps in windows and walls is mainly due to the poor construction technique and poor maintenance. Hence it was analyzed that locally available materials can be used in conjunction with modern materials and construction techniques to optimize its thermal performance and to reduce heat loss to create a favorable indoor thermal comfort. As per this study, it was found that the buildings constructed with modern technology with imported materials performed significantly better than traditional buildings. These buildings had their air infiltration rate at a minimum of 1 h⁻¹ w with less amount of crack and holes in their building envelope. It was observed that the modern construction techniques facilitate minimum air infiltration due to its adoption of new construction materials and better workmanship.

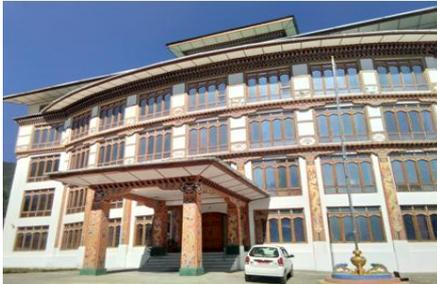
Figure 14: Building no.3: Office of Attorney General

This five storey office building was constructed in 2013 using a RCC frame structure with brick infill walls. The office building of Attorney General is located at an altitude of 2418 m. Modern construction techniques were adopted for the construction of this building. Timber windows are used in the building façade.

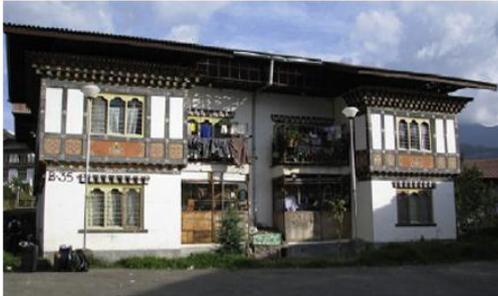
Figure 19: Building no.4: Residential building

This two-storied residential building is constructed at Changigi housing complex in 2011 by National Housing Development Corporation Ltd. It was constructed with RCC frame structure and brick infill walls using modern construction techniques. Apart from brick and concrete, the window and doors are made up of timber.

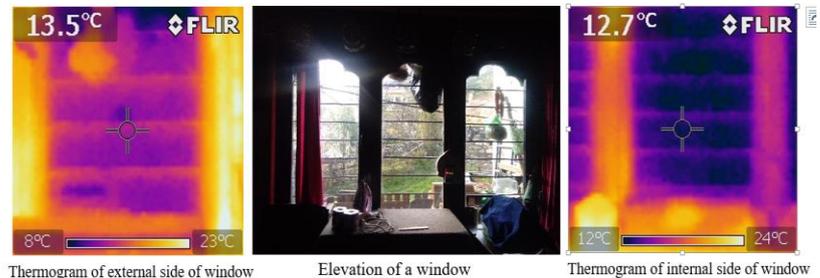
Figure 20: Thermogram of window surface

Thermal imaging of this typical window without sealing of the living room as shown in figure 20 was carried out on 27th October, 2018 at 4:40 p.m. The outdoor temperature was 16°C and internal temperature was 12°C with a humidity of 48% and the wind velocity of 10 km/h. It was observed that the outer and inner surface temperature of window glass was 13.5°C and 12.7°C respectively as shown Figure 20. Similarly, the outer and inner surface temperature of brick wall was 11.6°C and 10.9°C as shown in Figure 21. The air infiltration rate of this building was 0.8 h⁻¹ as per the study carried out by (Jentsch et al, 2017). Hence, this building was established as is air tight where, very less heat loss occurred through air gaps, due to the absence of cracks in the wall.
