**International Journal of Advanced Research in Science,
Engineering and Technology**

Vol. 6, Issue 1, January 2019

Impact of Sand Mining on Water Quality and Bank Morphology of Ontamiri River in Owerri Nigeria

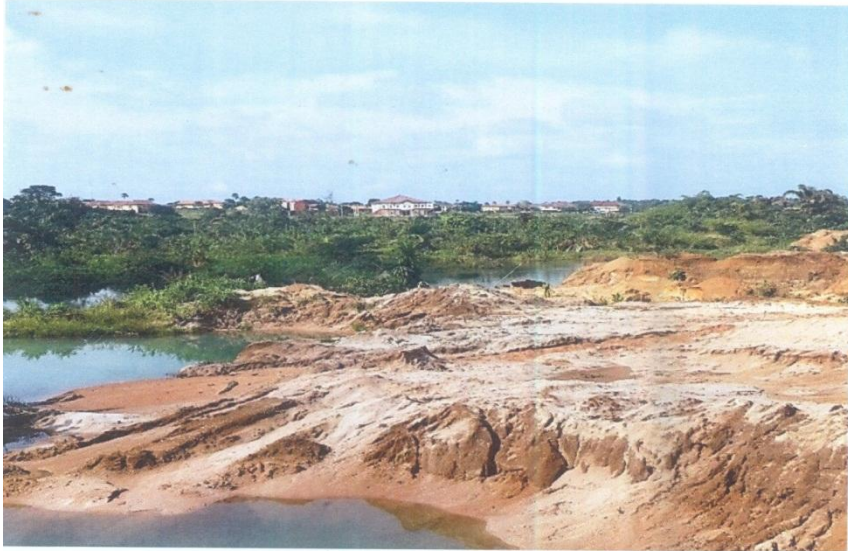
Observation of the impact of sand mining activity on bank morphology showed that the vegetation was destroyed where sand was excavated. This exposed the soil to raindrop impact and runoff, that caused bank erosion and collapse (figure 5).

Figure 5: A section of the altered Bank morphology of Otamiri River

In addition, the river banks widened with no definite morphology. The entire impact caused intrusion of soil particles, organic debris and nutrients into the river water. Biodiversity and aesthetic quality of the area were also destroyed.
