**International Journal of Advanced Research in Science,  
Engineering and Technology**

**Vol. 8, Issue 6 , June 2021**

# **Features of the influence of non-metallic inclusions on quality of oil and gas field equipment steels**

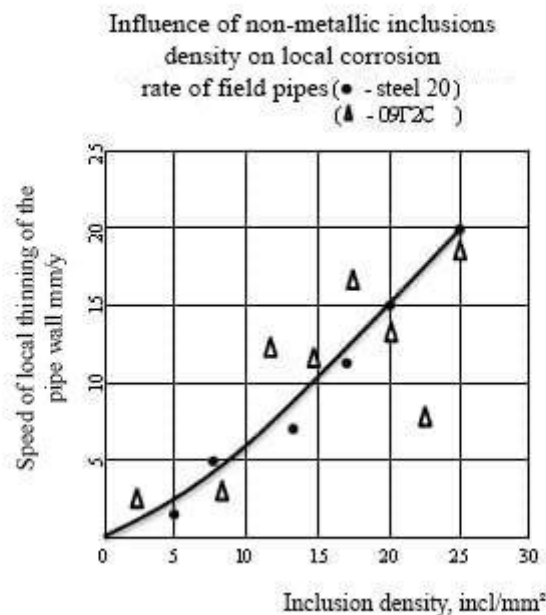
**Figure 1** - Effect of CAVI on steel properties

The effect of inclusions is usually strongest on the impact toughness, which is particularly sensitive to metal notches and stress concentrators (Figure 1). The decrease in impact toughness, for example, in the presence of string inclusions in the fracture plane, can reach 30-70%. String non-metallic inclusions can cause delamination of metal under external loads. This causes rapid wear and rejection of steel products. Globular oxide nonmetallic inclusions located on the contact surface reduce the wear resistance and fatigue strength of steel.

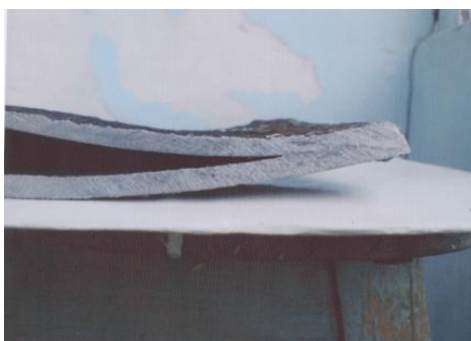
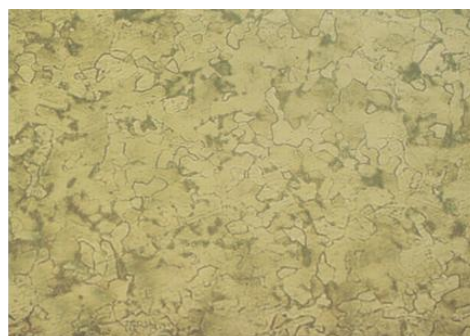
**Figure 3** - General view of a fragment of acid gas transportation pipe (a), the microstructure of the steel massive (b) and the steel structure in the swelling zone (c) ; $\times 200$

Figure 3a shows a general view of a pipe fragment for acid gas transportation. In operation since 1998, the working environment contains H<sub>2</sub>S+CO<sub>2</sub> up to 45-55%, SO<sub>2</sub> - 35-45%, hydrocarbons - up to 0,1-1%, temperature operation mode - up to +60°C.

The steel defect of the tested fragment of the acid gas transportation pipe is apparently caused by the process of hydrogenation by hydrogen released during hydrolysis due to CANI - string oxides.
