**International Journal of Advanced Research in Science,  
Engineering and Technology**

**Vol. 4, Issue 8 , August 2017**

# **Evaluation of Flexural Behavior of Steel- Concrete Hybrid Girder Using 80-MPa High-Strength Concrete**

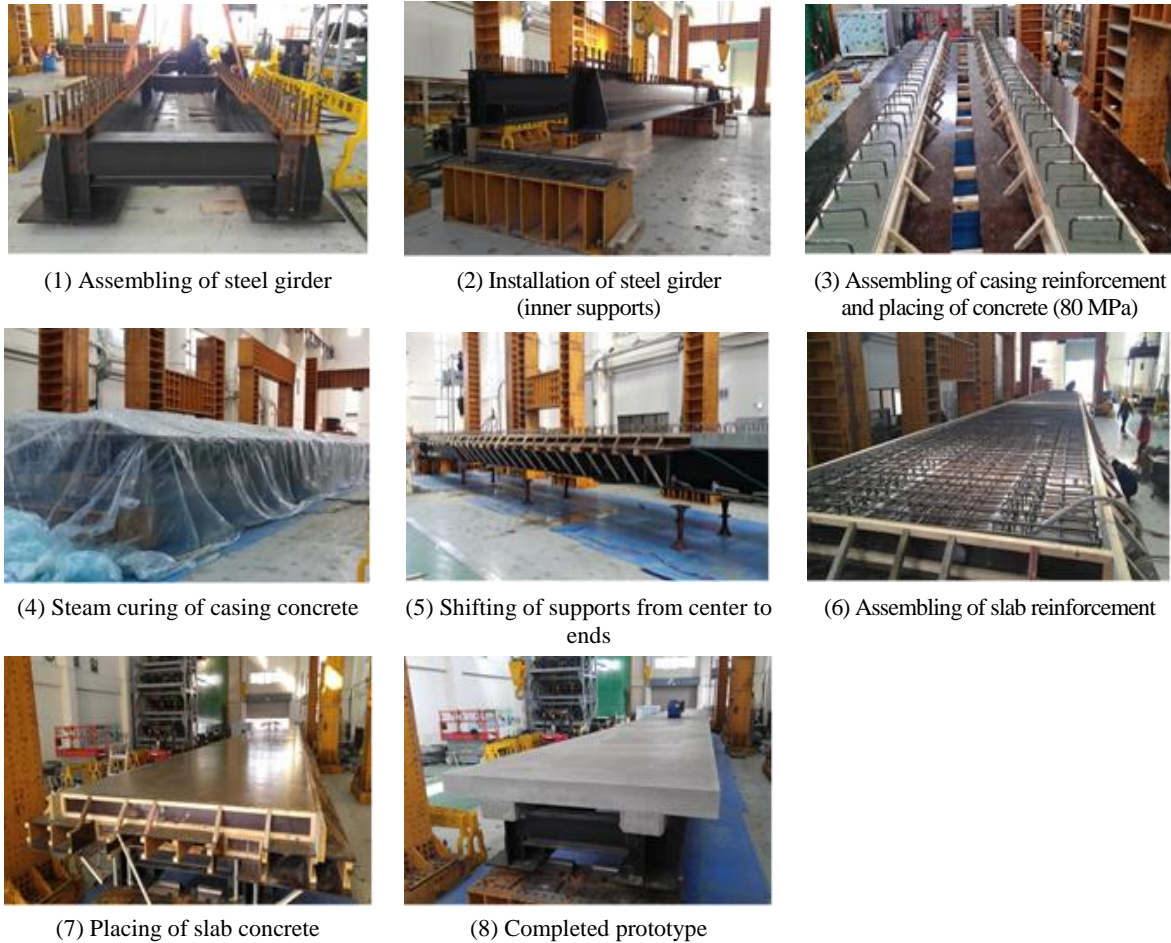
Fig. 4 Sequential fabrication of hybrid girder prototype

The prototype was fabricated stepwise following the sequence shown in Fig. 4.

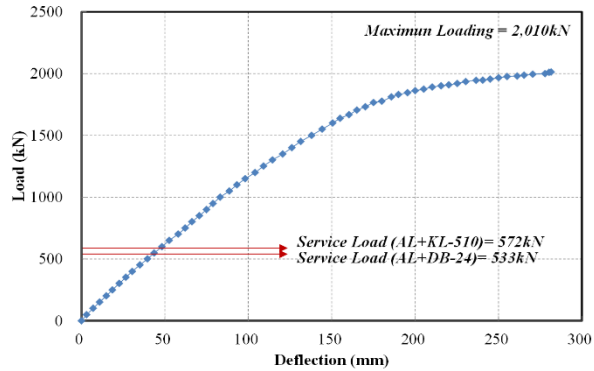
Fig. 8 Load-deflection curve measured at central section

Fig. 8 plots the load-deflection curve measured in the bending test up to failure. The prototype is shown to develop linear behavior until the design load. Fig. 9 plots the load-strain curves measured in the central section. Yield behavior of the lower flange started near 1,800 kN corresponding to about 3.1 times the service load. From that point, the prototype exhibits nonlinear behavior which may indicate that the yield behavior of the lower flange governs the overall flexural behavior of the girder.

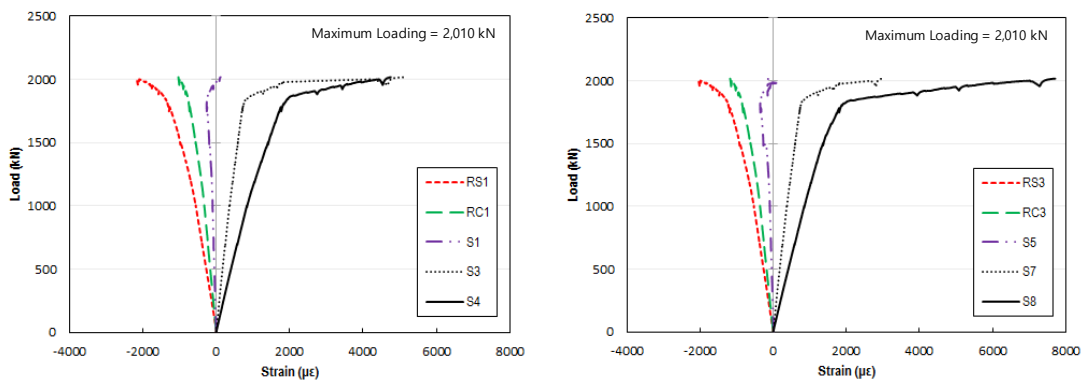
(a) G1

(b) G2

Fig. 9 Load-strain curves measured at central section

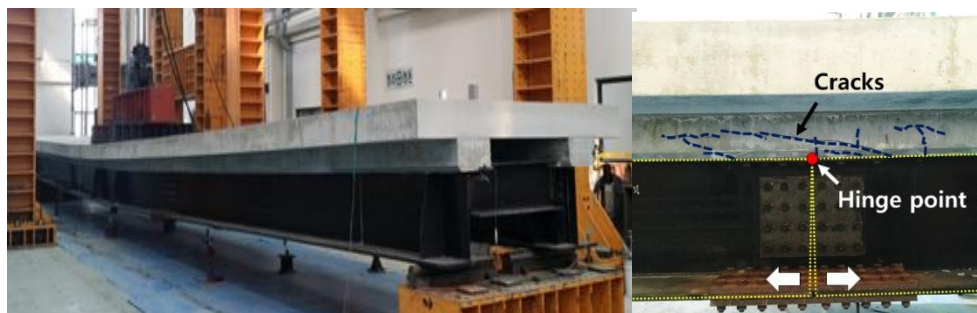
Fig. 10 Failure and crack pattern of concrete at bolted connection of girder

After the start of the nonlinear behavior, failure occurred around 2,010 kN that is lower than the value of 2,475 kN computed for the ultimate load in the design check. At that time, sudden tensile failure occurred in the concrete casing at the bolted connection of the girder. This sudden failure was totally unexpected without anticipative cracking in the concrete casing, and appeared by the gaping in the butt connection of the girder due to the flexural deformation. This led to the appearance of a hinge in the concrete casing (Fig. 10) that resulted finally in the failure of the girder. Even if slip or gaping did not occur in the bolt holes drilled for the bolted connection after the pre-assembly of the girder, the actual fabrication of the prototype could not prevent some loosening by the fastening of the bolts in the pre-drilled holes.
