# **Assessment of the Technical Condition of the Reinforced Dome Construction of the Kalyan Mosque under the Influence of Seismic Forces**

**Z.S. Shadmanova, B.K. Raxmanov, A.S. Yuvmitov**

**ABSTRACT:** In the article was analyzed the technical condition of the dome construction of the Kalyan Mosque in Bukhara after reinforcing with metal profiles as a result of theoretical calculations. Using a special computer program, the dome structure was calculated separately from the accelerogram of the existing SA-482 model by the finite element method, and its stress-strain state was determined.

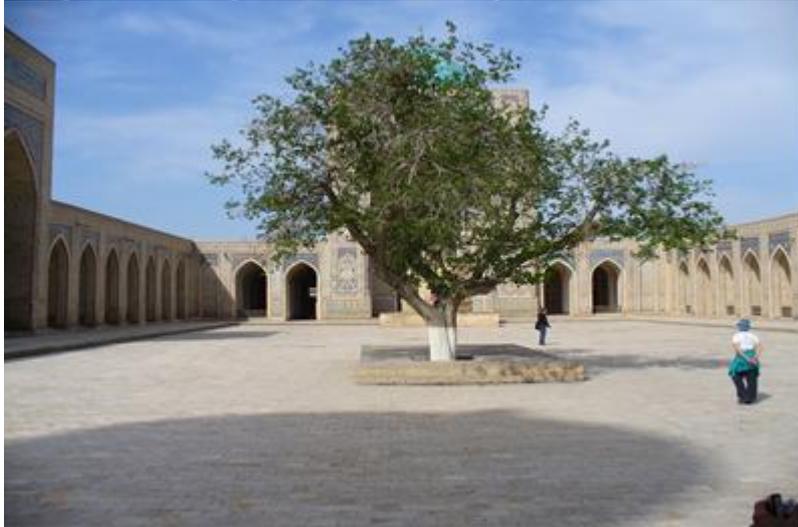
**Figure 1.** General view of the interior of the Kalyan Mosque

Strong earthquakes that have occurred in certain periods and the recent rise in groundwater levels have caused deformations in the mosque's structures. In addition, cases of erosion due to moisture in the lower part of the walls of the mosque were observed [3].

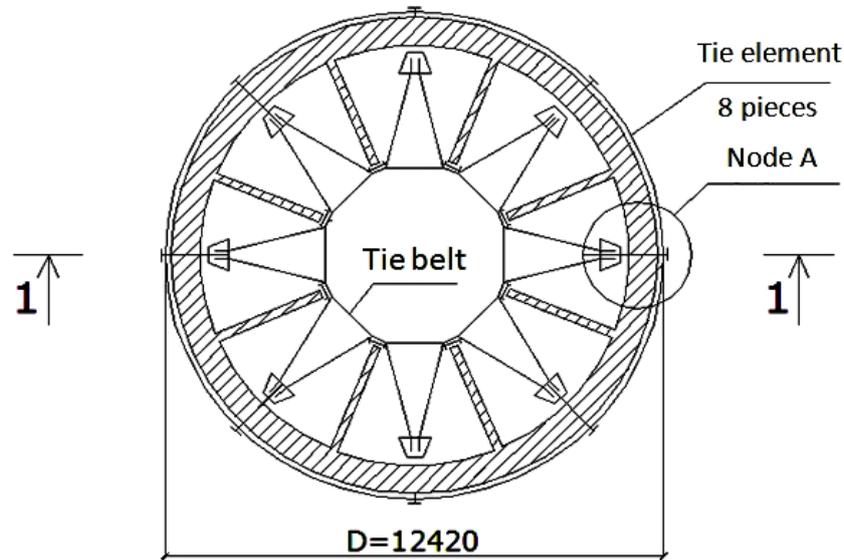
Figure 4. Drum construction plan (2-2)

The main material of the entire mosque complex is burnt brick, the dimensions of which are 0.22x0.22x0.05 m. These bricks were assembled using a mixture of gypsum [5]. One of the main structures of the mosque is the dome structure, which was damaged during the earthquake and was quite damaged. During the repair, it was reinforced with a cable-stayed construction using steel profiles, which was not entirely based on engineering calculations. The brick buttress diaphragms located on the inner side of the dome under the dome are attached to the connecting belt using rolled channels and are attached to the drum wall using bolts and nuts using a steel rope. Due to the fact that most of the republic's territory is located in seismic zones, a theoretical study of the influence of this strengthening structure on the structure of the drum during an earthquake is important and relevant. One of the main solutions to this is to perform computational work using Lira Soft based on the finite element method available in construction practice [6]. The geometric dimensions of the drum structure and the strengthening steel profiles in it are shown below (Figures 3, 4, 5).

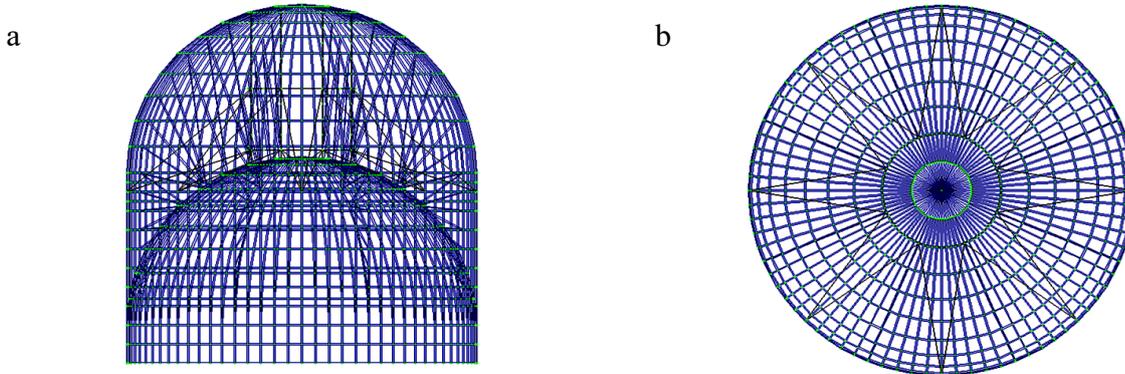
**Figure 7.** View from the side (a) and under the dome (b) after strengthening the dome structure using the cable-stayed construction
